2. Subbasin Assessment – Water Quality Concerns and Status

2.1 Water Quality Limited Assessment Units Occurring in the Subbasin

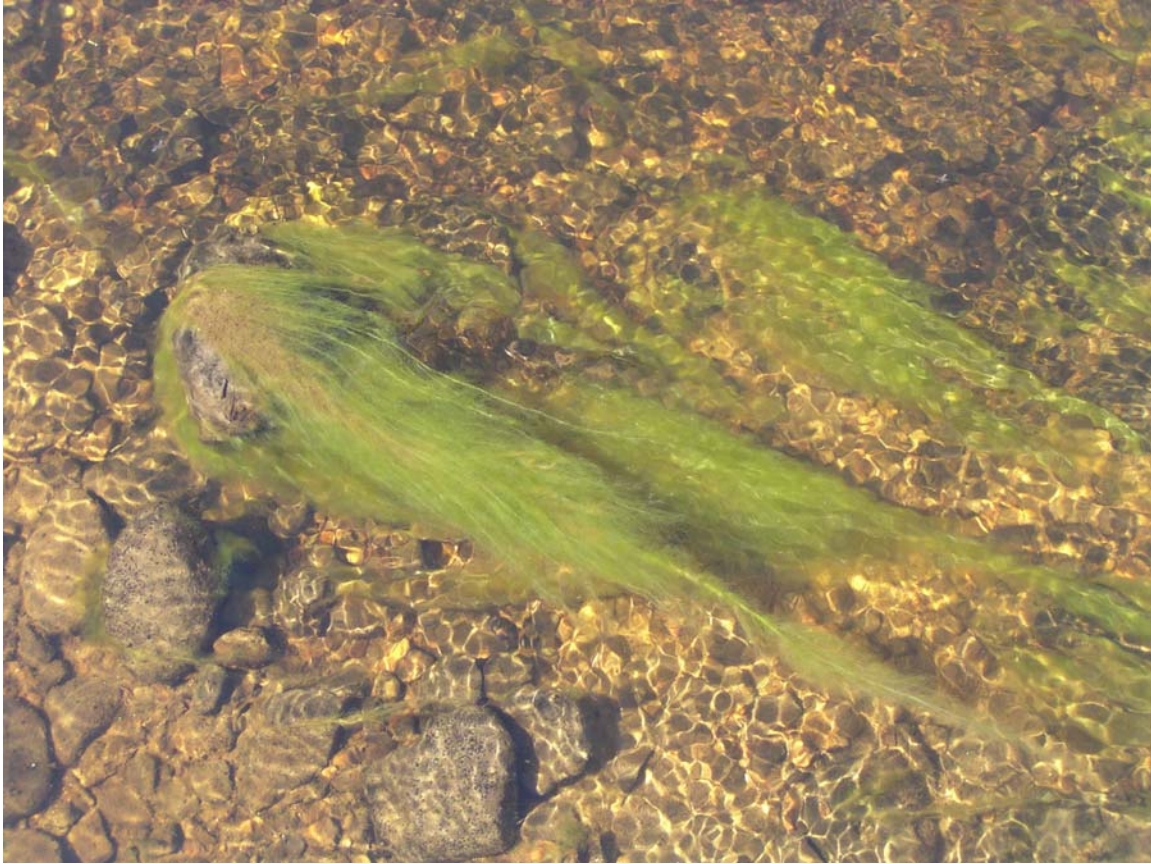
Figure 23. Periphyton Present at Little Salmon River at New Meadows.

Nutrient monitoring showed that nutrient concentrations were low in the lower reach of the Little Salmon River (LSR 1 and LSR2) (see Appendix C for results). Elevated nutrient concentrations were seen at LSR 3 (LSR at Circle C Ranch) and LSR 4 (LSR at New Meadows), particularly from late July through August when flows decreased. This time period also coincided with the appearance of nuisance periphyton growth. Phosphorus concentrations were consistently lower at the downstream LSR3 site (Figure 24). The Idaho Department of Agriculture surmised that high levels of organic phosphorus found in the water quality analysis are from algal die off or periphyton sloughing off. Decreased concentrations downstream may be due to the use of phosphorus by periphyton or other algal species.

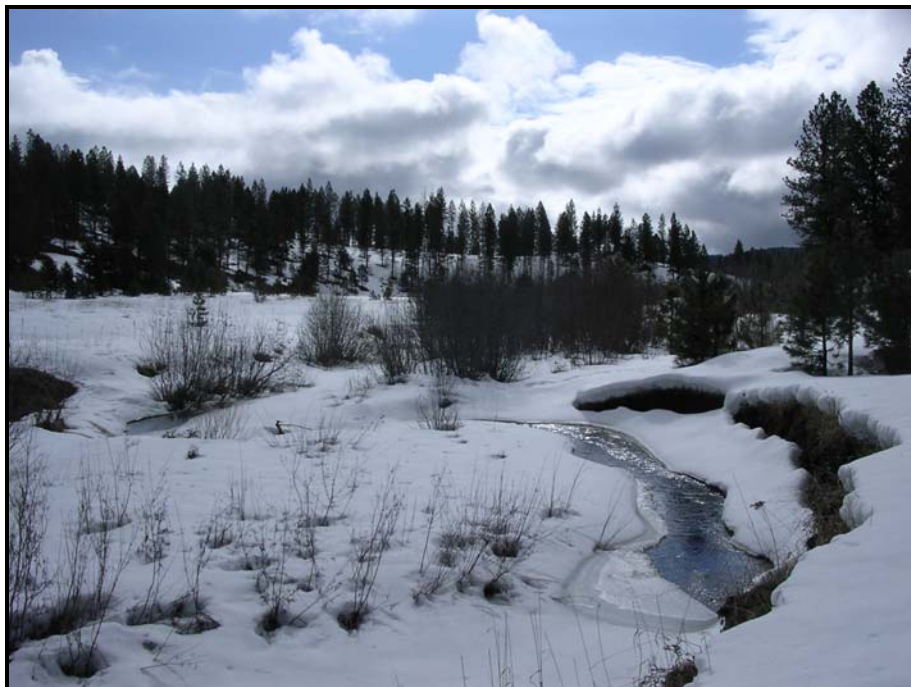
Figure 27. Mud Creek (March 2005).

A moderately sinuous stream, Mud Creek is a Rosgen Stream Type (RST) C at the lower open meadow elevations (Figure 27). Within the middle elevations, Mud Creek has RST B characteristics. It is moderately sinuous, moderately confined, and has an average gradient of 5%. Above 4,760 feet in elevation, the RST is mostly RST A. The substrate changes to boulder with some granite outcroppings.

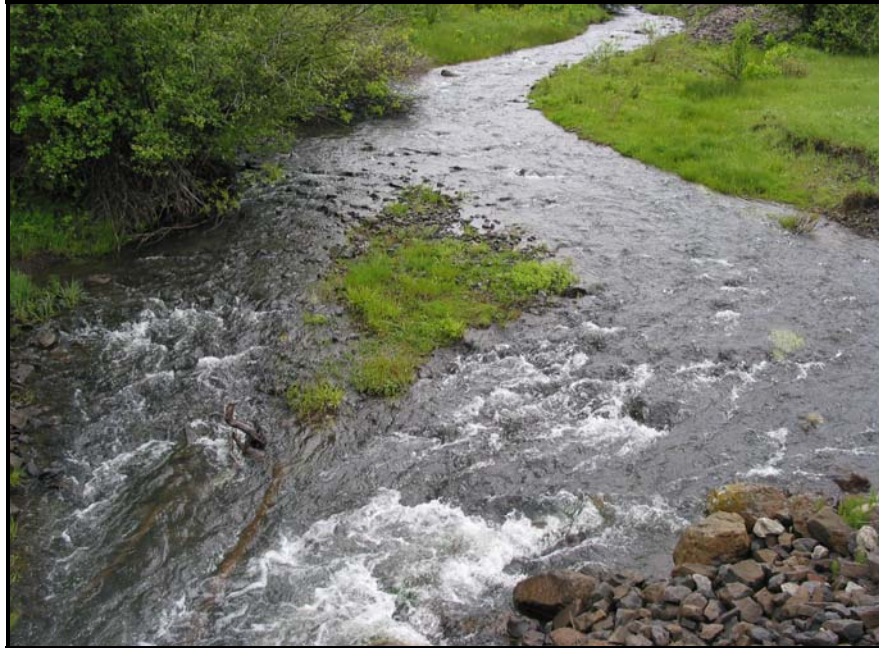
Figure 30. Big Creek (BC2, June 2003).

Big Creek originates south of the Little Salmon River at 6,600 feet on the east side of Blue Bunch Ridge (Figure 30). It flows north through forested and meadow areas, and enters the Little Salmon River about a mile southwest of New Meadows (approximately 41 miles upstream of the mouth of the Little Salmon River). The watershed drains 18,592 acres. Assessment unit 17060210SL009_02 comprises of the Big Creek watershed.

Water is removed from Big Creek for irrigation of pastureland, and fluctuations in flows between BC1 and BC2 are likely attributable to water management. Figure 30 shows the location of BC1 and BC2 monitoring sites. Figure 31 shows the change in water flow between the BC1 and BC2 sites.

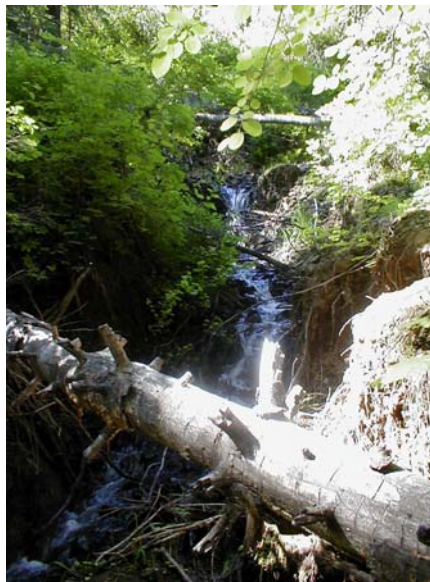
Figure 42. Three Mile Creek (Summer 2002).

Three Mile Creek was surveyed by the USFS in 2002 (Figure 42). The section of stream surveyed began at the forest service boundary and ended approximately 1.5 miles upstream at the road 303 crossing. The streambed is moderately confined and meanders slightly in the lower reach. The middle reach streambed has extensive braiding and many side channels throughout. The upper reach is very confined with few side channels. The reaches surveyed

The large woody debris exists mostly across the streambed but not necessarily within the stream channel. Most of the woody debris was aggregates of branches, live alder, and dogwood, and a few large logs that appeared to be placed as bank stabilizers decades ago. Bank stability varied from very low (< 65%) with active erosion prevalent to stable or solid rock bank. A 2003 Pfankuch Channel Stability Evaluation found the mainstem of Threemile mile Creek on forest service lands to be in fair condition.

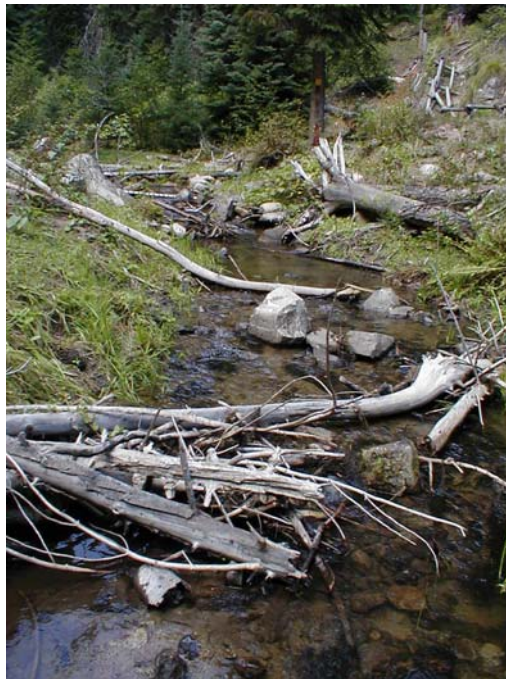
Figure 43. Round Valley Creek.

Round Valley Creek (**Figure 43**) is upriver of the Little Salmon River barriers and flows into the Little Salmon River at river mile 25.3. It is a third order stream which originates on the eastern slopes of Brush Mountain, elevation 6,247 feet. The lower reach meanders through meadows in wide valley bottoms.

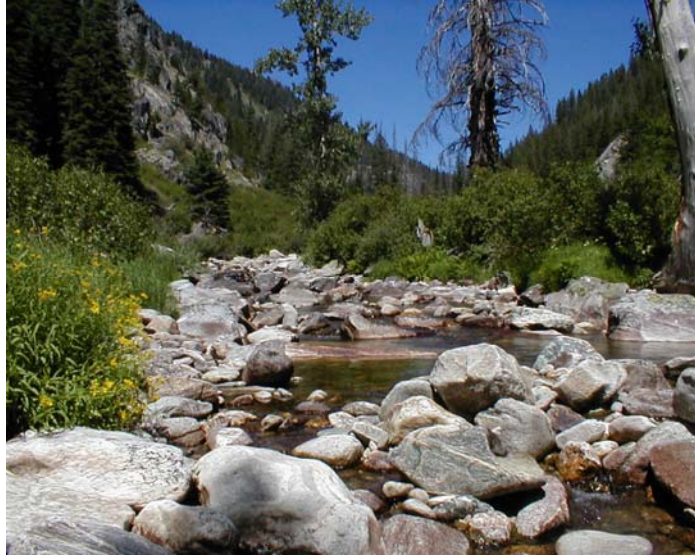
Figure 47. Hard Creek, a Tributary of Hazard Creek (August 2003).

Hard Creek (**Figure 47**) is a fourth order stream and enters Hazard Creek at stream mile 0.9. The drainage area of Hard Creek (24,053 acres) is slightly smaller than Hazard Creek (27,865 acres). The Hard Creek drainage is bordered by the Grass Mountains on the north, Granite Mountain (elevation 8,478 feet) on the south, Bally Mountain (elevation 6,818 feet) on the west, and an unnamed mountain (elevation 8,255 feet) on the east. Hard Creek flows west and north until it enters Hazard Creek.

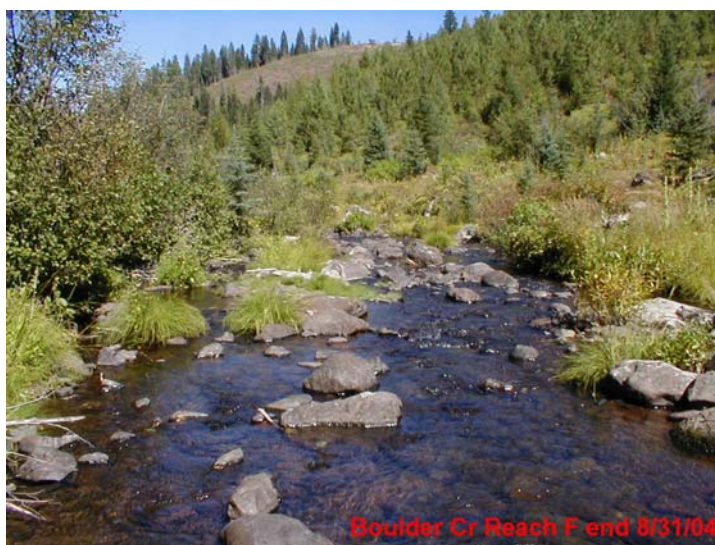
Figure 53. Middle of Boulder Creek Watershed (August 2004).

The lowermost portion of the watershed is primarily private land (3% of the total watershed) and BLM managed public land (3% of the total watershed), and the upper portion of the watershed is Forest Service managed public land (94% of the total watershed) (Figure 53).

Boulder Creek headwaters are undeveloped and in National Forest Service land. The rest of the creek has been impacted by stream alterations including removal of large wood from the floodplain and hardening of the stream banks. These alterations are believed to have contributed to decreased production of Chinook salmon, steelhead, bull trout and Westslope cutthroat trout (IDWR 2001).

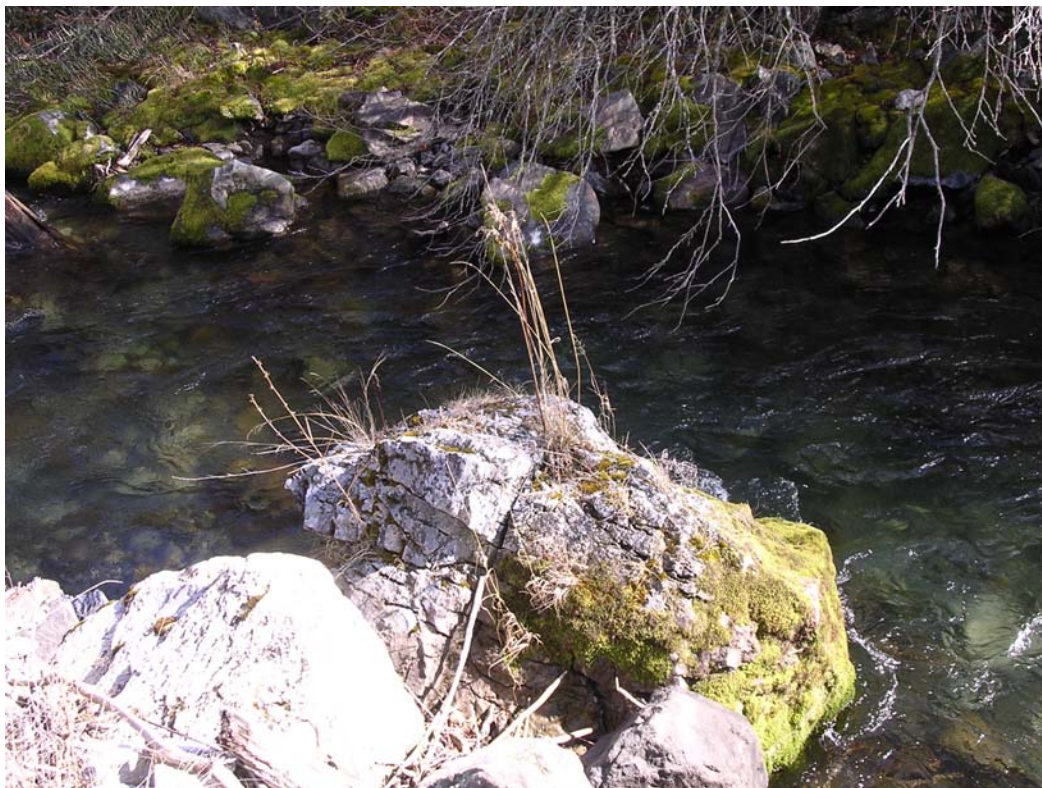
Figure 65. Rapid River Upstream of Fish Hatchery (March 2005).

Rapid River is a fifth order tributary to the Little Salmon River, located about four miles south of Riggins (Figure 65 and Figure 66). The entire watershed is 80,017 acres in size, 21,991 acres of which are in West Fork and 7,919 acres in Shingle Creek. Aside from the West Fork, major tributaries include Paradise Creek, Lake Fork and Granite Fork. The upper watershed features bare rock and alpine lakes, such as Black Lake, Crystal Lake and Satan Lake.

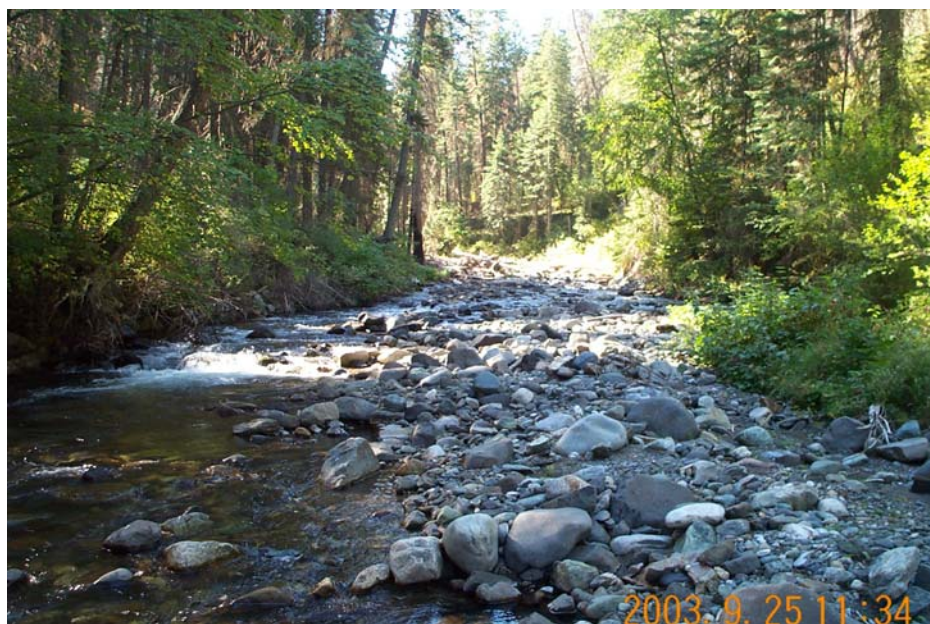
Figure 68. Rapid River (September 2003).

Rapid River has a narrow stream channel with a mean width of 8 meters comprised largely of high gradient riffles, cascades and other fast water types (Figure 68).

The substrate is primarily cobble-rubble with some boulder within the lower to middle reaches. The swift RST B has some short RST A cascades within the confined canyon. As the stream approaches its headwaters, the substrate is more cobble to gravel sized with pocket pools behind boulders.
